Manhole Inspection Summary

Manhole # S21O__004MH

Insp Date: **3/13/08 8:10 AM**

Location Address: **1900 s payson st**

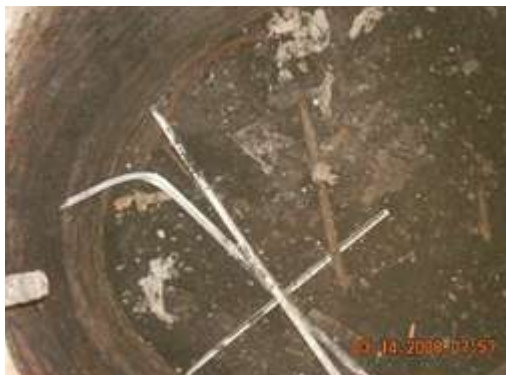
Defect 2

Condition: ☐ Sound ☐ Cracked ☐ Root Intrusion ☐ Deteriorated ☐ Leaks ☒ **Debris**

debris in the bottom of the terminal

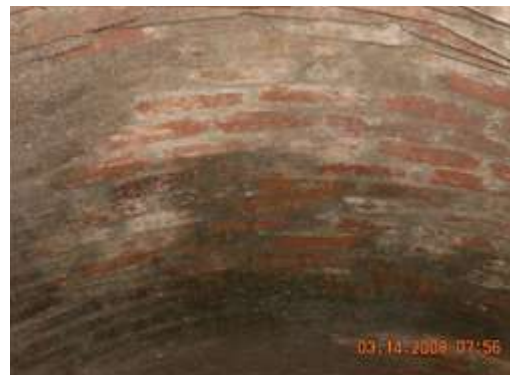
Defect 1

Infiltration: ☐ None ☐ Joint ☐ Cracks ☐ Mortar ☐ Roots ☒ **Wall**

infiltration @ barrel wall

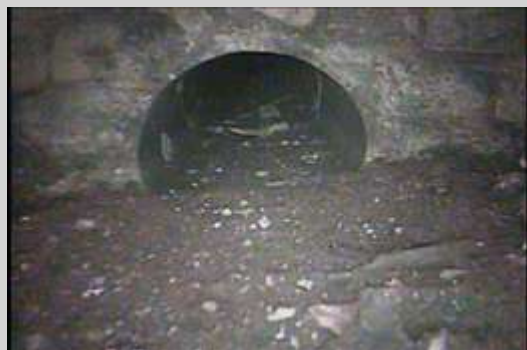
12 O'Clock Outflow

8 in. Circular Gravity Sewer
Pipe Out @ 12 O'Clock

Deposits: ☐ None ☒ **Mud** ☐ Sludge ☐ Debris ☐ Grease

Silt Depth: **2** (in.) Deposits Extent: **Light**
